Coastal Erosion at Ballygrangans

An information sheet compiled, produced and distributed by Jim Hurley, SWC Promotions. E-mail: swc@eircom.net

Updated June 2006

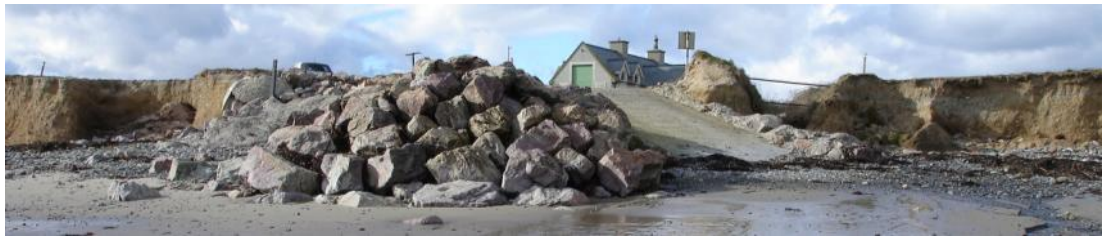
A pile of large boulders of quartzite rock quarried on Forth Mountain (right) was placed on the beach to protect the point where an Esat submarine fibre optic cable was brought ashore in May 2000 from Whitesand's Bay, Cornwall. Note how the shoreline has retreated to the left and right of the rocks as the soft cliffs are eroded by the sea. When the slipways were built in March 2004, the cliffline was 1m behind the seaward point of intersection of the two slipways.

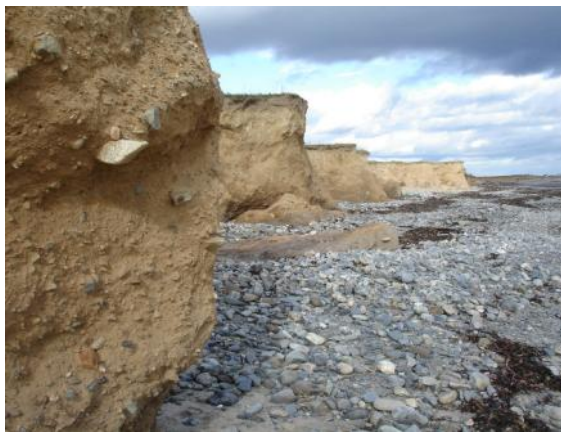
Coastal erosion by the sea has formed cliffs at Ballygrangans (above). The cliffs are composed of the sediment left behind when the glaciers melted some 10 000 years ago at the end of the last Ice Age. The material is mainly mud loaded with coarser rock particles. Such unsorted glacial material is variously known as till, drift and boulder clay. In places, meltwater flowing from the glacier sorted the parent material into layers of purer sediments. Coastal erosion extracts the unsorted material from the cliff, wave action sorts it, and longshore drift carries the lighter fraction out to sea or away to the east leaving the boulders and cobbles behind on the beach.
