# Lady's Island Lake Feeder Streams

## 1. INTRODUCTION

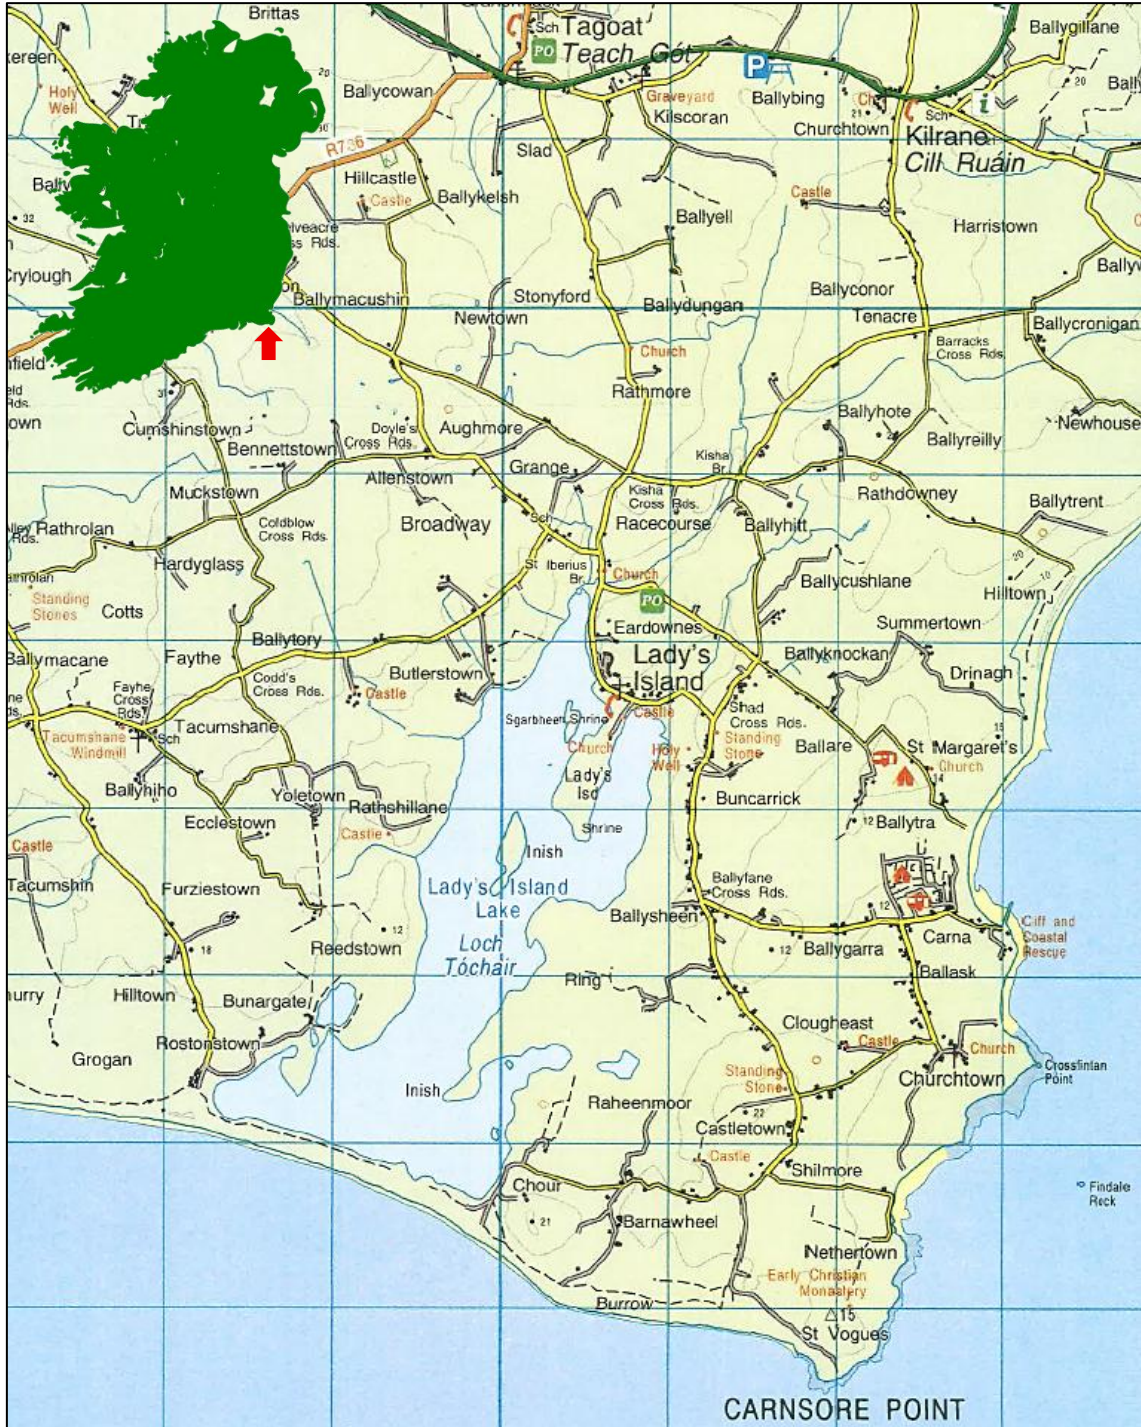
Figure 1. Lady's Island Lake and its feeder streams. Grid side = 1km.

Lady's Island Lake and its feeder streams are featured below (Figure 1).

(Source: Scan of part of hard copy of Tailte Éireann Discovery Series Sheet 77)

While Figure 1 features Lady's Island Lake and its feeder streams admirably, the Discovery series is not listed among the twelve map types that comprise the GeoHive Map Viewer basemap gallery (<https://www.arcgis.com/apps/webappviewer/index.html?id=3ae19cc156bf4706a929304bf8fcc4f6>).

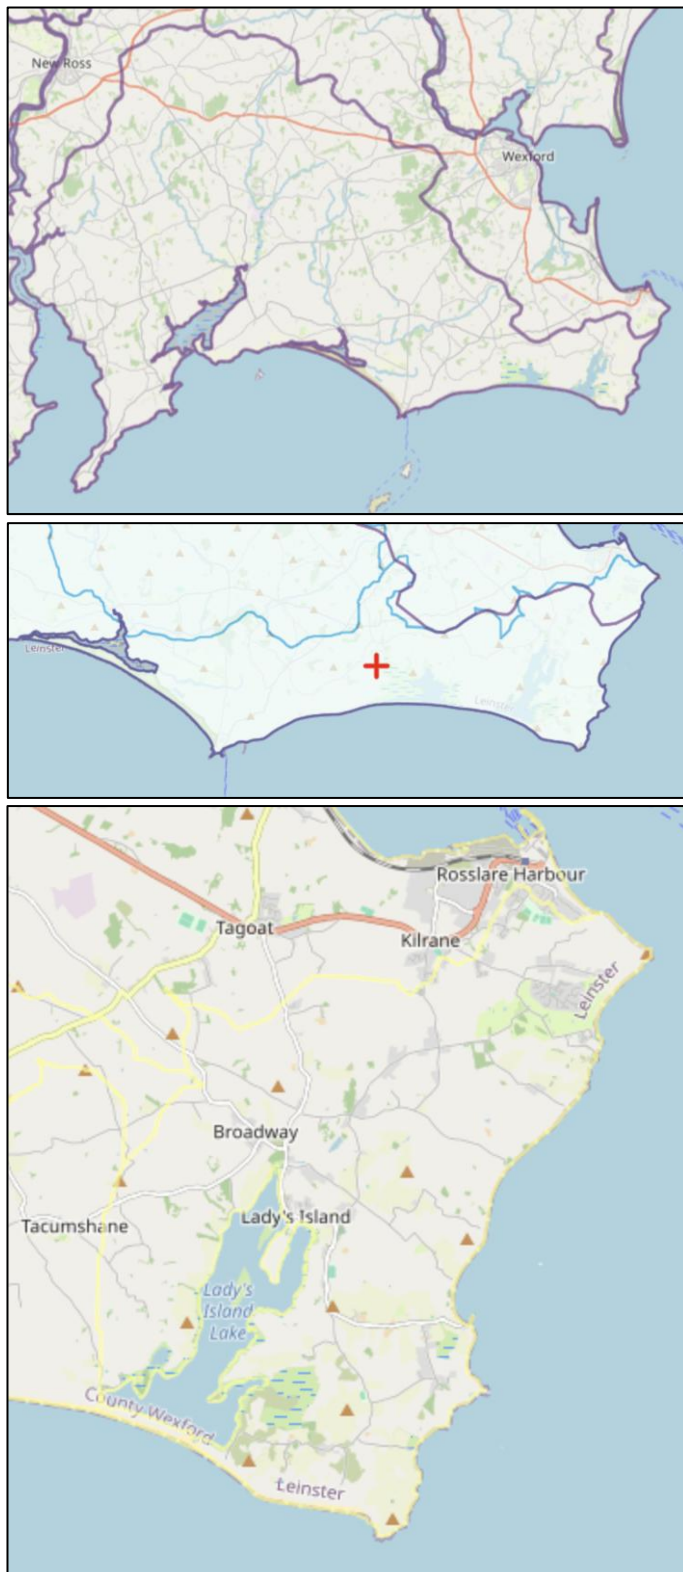
Figure 3. Lady's Island Lake water regions.

1. **Hydrometric area.** Lady's Island Lake is in hydrometric area (HA) No 13, name 'Ballyteigue-Bannow', code IESE, area = 654km<sup>2</sup> (Figure 3, top, edged bold blue line).

4. **River sub basin.** The Lady's Island Lake WFD river sub basin is named KISHA\_010, EU code IE\_SE\_13K140950, area = 29.69559179km<sup>2</sup> (Figure 3, bottom, edged by the feint yellow line).

3. **Subcatchment.** The catchment is divided into five subcatchments. The subcatchment that contains Lady's Island Lake is named KISHA\_SC\_010, identification code 13\_4. That subcatchment extends eastwards from the estuary of the Duncormick River to Carnsore Point. In Figure 3, (middle) the darker blue line delineates the hydrometric area boundary, and the paler blue line delineates both the catchment and the subcatchment boundaries.

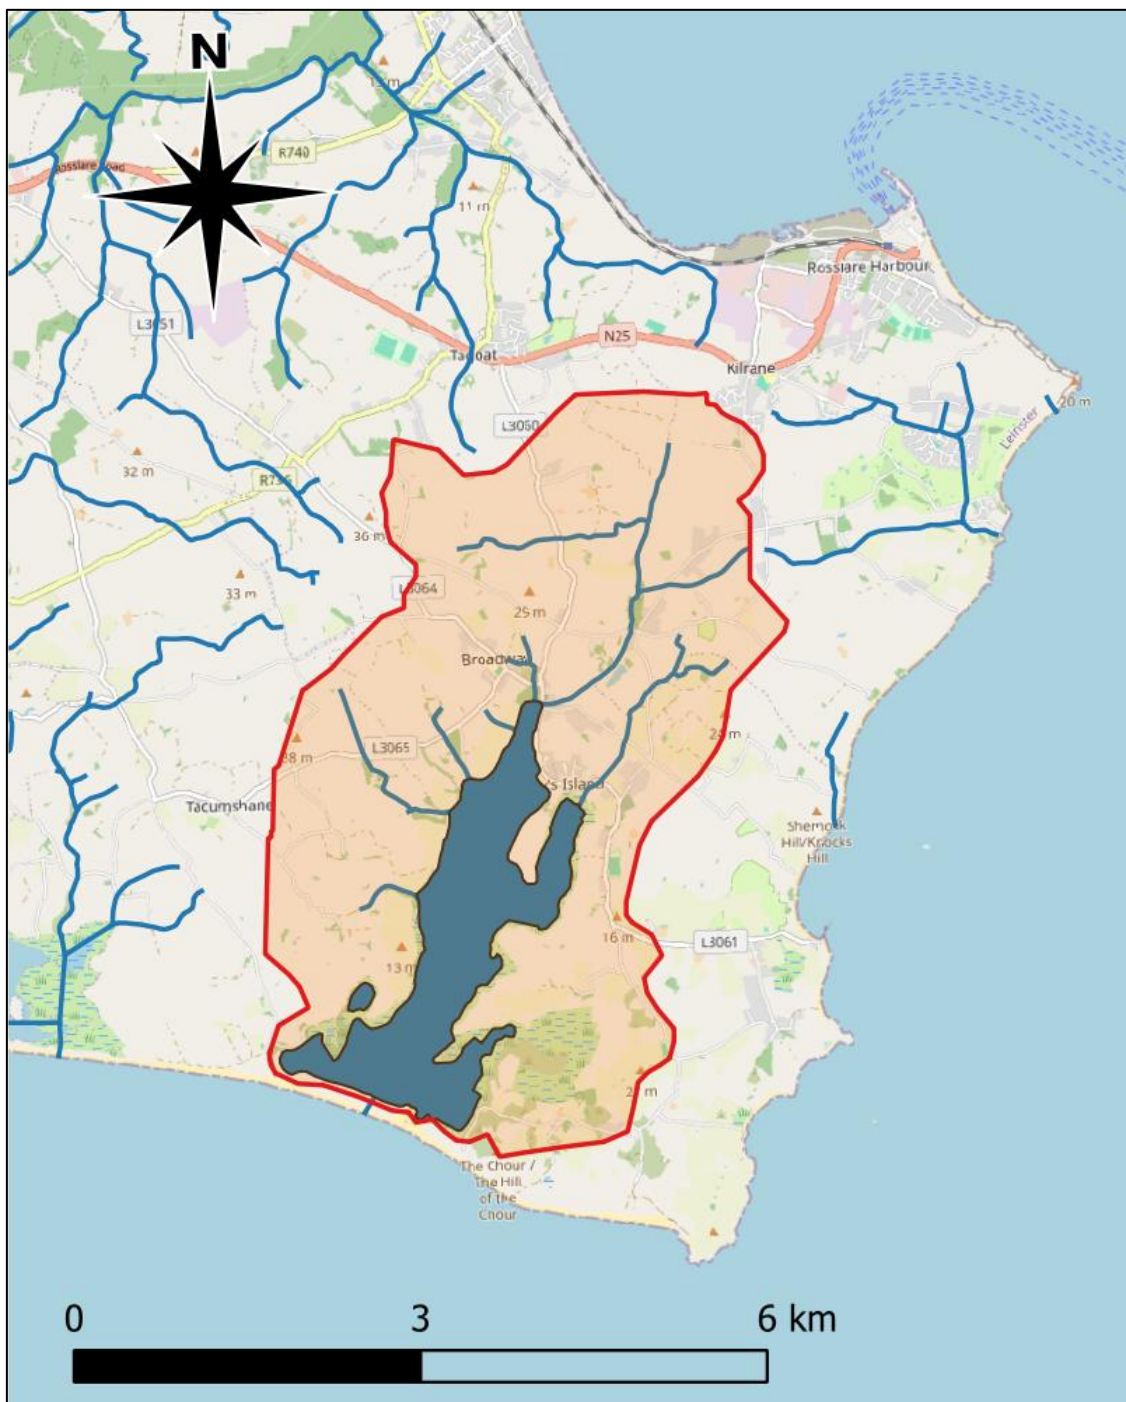
Figure 4. Lady's Island Lake and river waterbodies.

5. **Lake catchment.** The lake catchment (Figure 4) is the part of the river sub basin that drains to Lady's Island Lake. Its area is 19km<sup>2</sup> approximately (19.16km<sup>2</sup> (O'Connor *et al.*, 2024 pages 2-3) and 18.9km<sup>2</sup> (MW&P, 2012 page 5).

Currently, pursuant to the WFD, the Environmental Protection Agency (EPA) maps seven named river waterbodies discharging to the lake [[https://gis.epa.ie/EPAMaps/Water / Water Features / Flow Network \(indicative\)](https://gis.epa.ie/EPAMaps/Water/WaterFeatures/FlowNetwork(indicative))]. Figure 4 shows Lady's Island Lake (darker blue fill), the seven EPA feeder streams (lighter blue), the catchment of the lagoon (pale orange fill), and its indicative watershed (red line; after O'Connor *et al.*, 2024 page 2, Figure 2.1 and Figure 5 below).

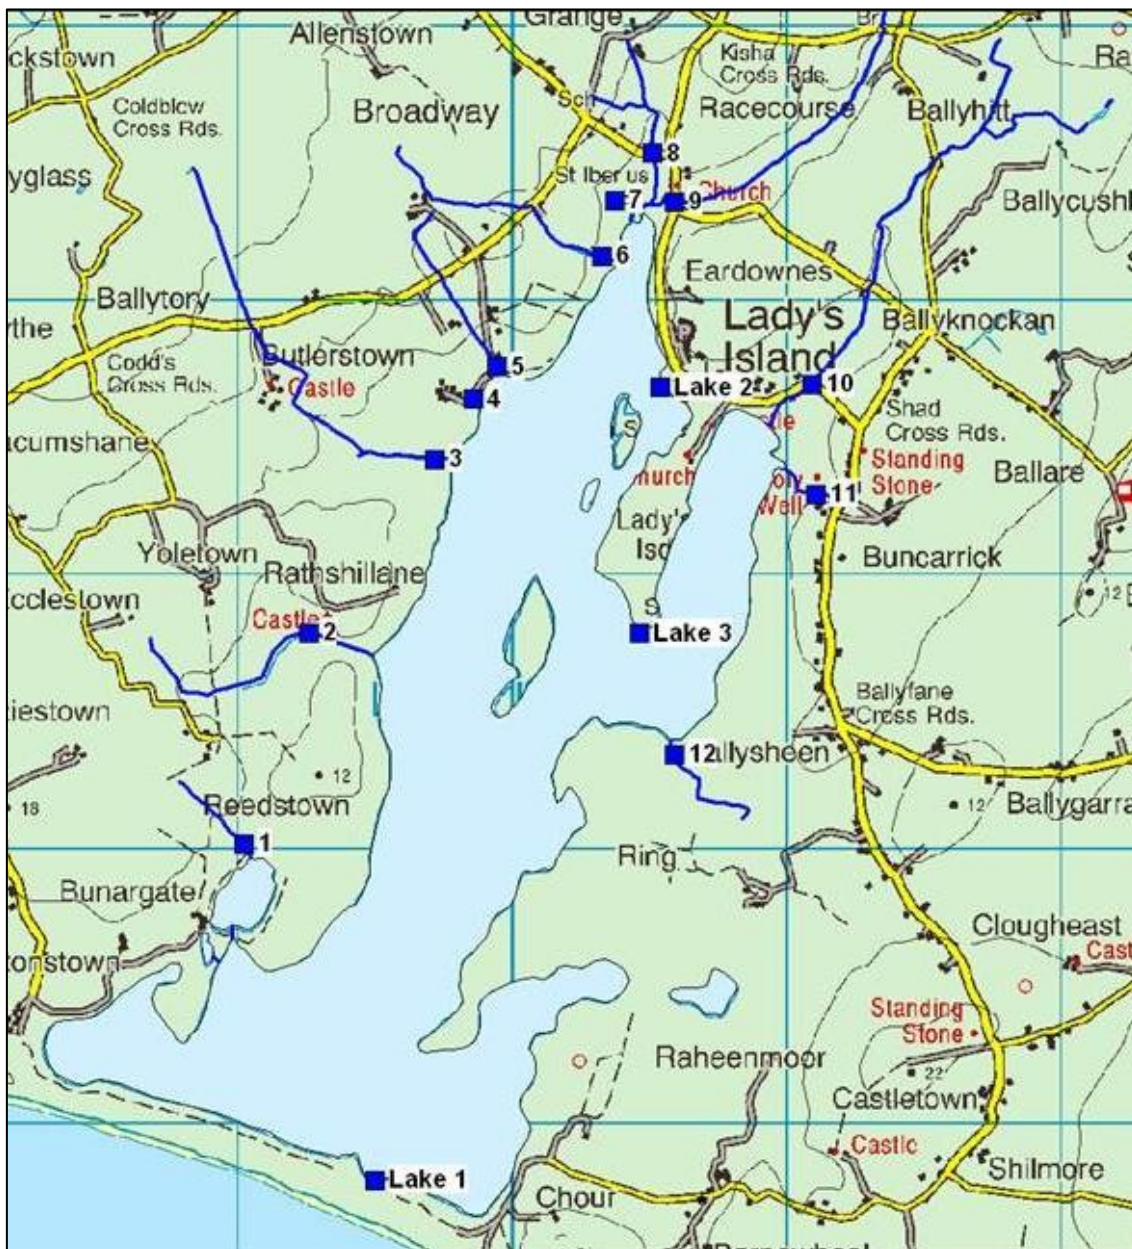
Figure 7. WWC feeder stream sampling stations 1-12 at Lady's Island Lake.

The accompanying table (Table 1, right) reconciles the numbers of the twelve feeder streams traditionally monitored by both the EPA and WCC (Figure 7) with the seven named river waterbodies recognised by the EPA for WFD monitoring and reporting purposes.

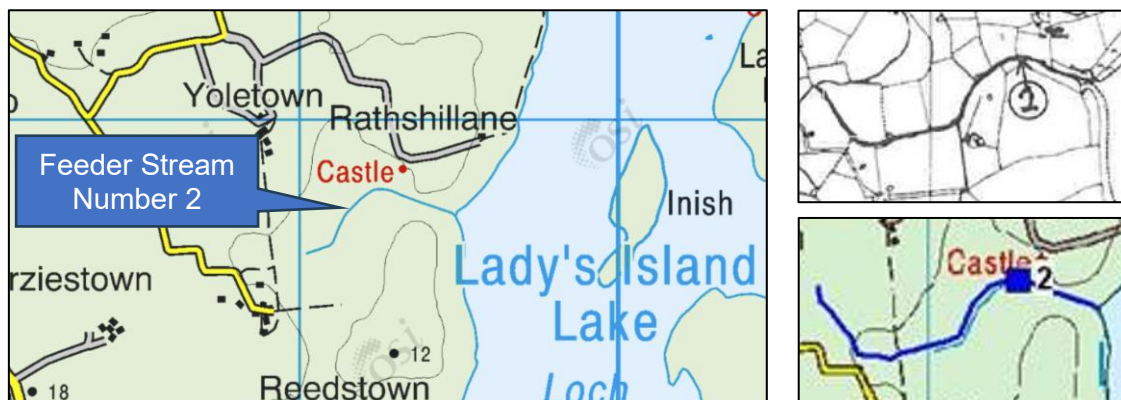
## 7.2. Feeder Stream Number 2

| Parameter | Sources |
|---|---|
| Location image | Figure 1 (= Figure 4) and extracts of Figure 6 (top) and Figure 7 (bottom) adjoining. |
| Characteristics | <p><b>Rises:</b> Near the 10m contour line.</p> <p><b>Direction of flow:</b> Variable easterly. Its course defines the townland boundaries between first Reedstown/Yoletown and then Reedstown/Rathshillane.</p> <p><b>Discharge point:</b> On the Reedstown/ Rathshillane townland boundary on the lake shore.</p> |
