Tacumshin Lake

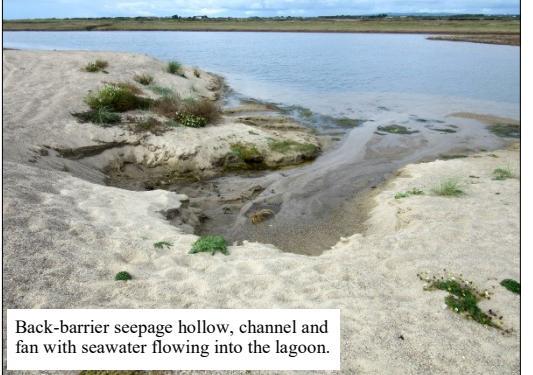
At high water, especially during storm surges, seawater from the adjoining Celtic Sea runs up the beach in an attempt to overtop the fringing barrier and spill into the back-barrier lagoon. It normally fails to do so in places where the barrier is high (>6m). However, the run of seawater up the beach face - the swash - temporarily raises the beach water table causing its landward front to migrate inwards and the spring line on the back barrier to disgorge seawater via a series of seepage springs. It appears likely that springs more commonly occur at points where the barrier sediment is coarser and more permeable. The flow from the each spring saps the back of the barrier excavating an amphitheatre-like hollow. The running water washes away sediment, erodes a channel and forms a seepage fan extending from the spring to the lagoon.

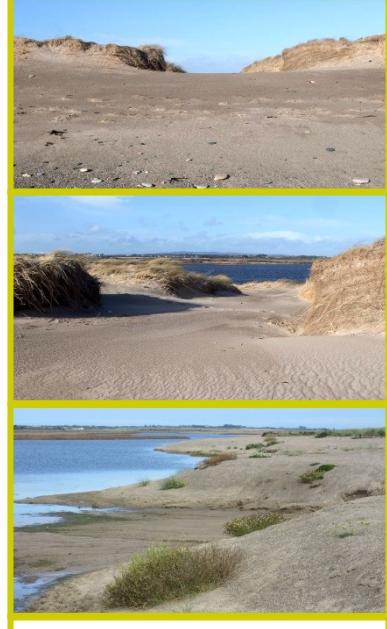
Top: Crestal throat where the swash on the beach penetrated the barrier ridge. Middle: A washover channel running down the back-barrier slope from the crestal throat to the lagoon. Bottom: The snouts of a series of washover fans protruding into the lagoon.

In places where the barrier is of medium height (4-6m) the sea irregularly overwashes the barrier crest in stormy weather and forms discrete washover fans on the back-barrier slope. (Overwashing is the process; washovers are the products.) Washover fans may be small or big and consist of three parts: (1) a throat, that is, a gap or opening in the barrier crest where the swash penetrated the ridge, (2) a river-like sediment flow running down the back-barrier slope and (3) a terminal fan spreading out and spilling into the lagoon.

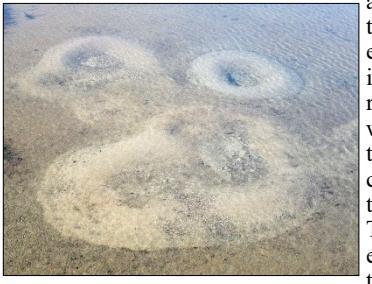
and fall varies 0.1-0.5m with lake level; the amount of rise and fall decreasing as lake level rises⁵. As a result, there is a strong salinity gradient from south to north⁶. The image above shows seawater issuing from springs on the lagoon bed as seen through shallow water.

The barrier is porous and there is significant throughflow under the barrier especially in places where it is narrow and where it has a high proportion of coarse sediment. As a result of throughflow, water level in the lagoon rises and falls

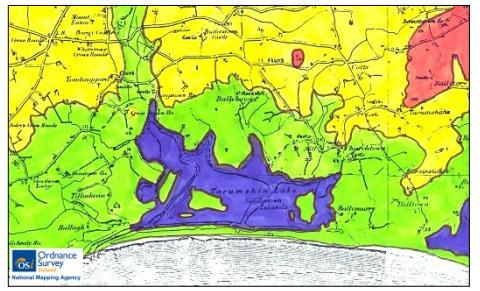
The catchment of Tacumshin Lake has an area of $36-40 \text{km}^2$ and is generally flat^{5 & 8}. The catchment extends to the villages of Kilmore (west) and Ballycogley (north). To the east, it extends almost to Broadway. The land is relatively low-lying (<15m; green colour below) and is predominantly utilised for agricultural enterprises and dispersed residential settlement.

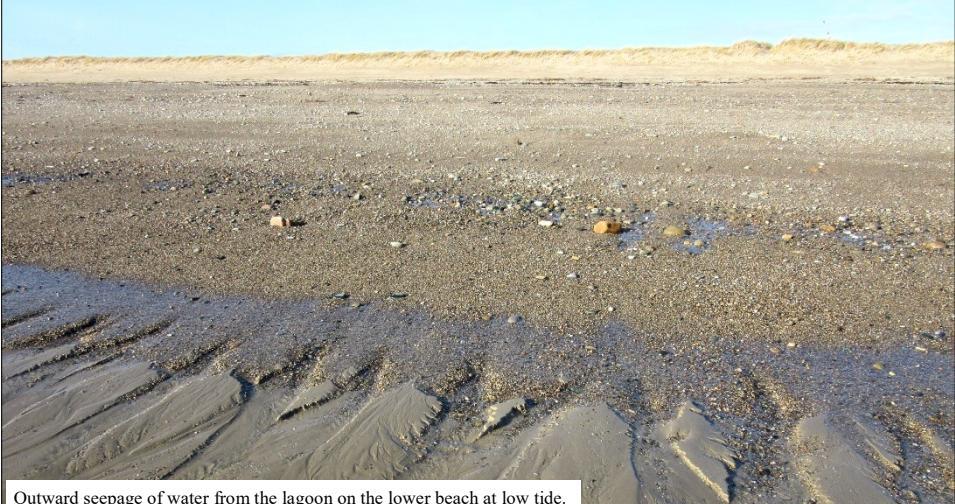
Outward seepage of water from the lagoon on the lower beach at low tide.

Outward seepage of water from the lagoon to the sea can often be seen on the lower beach when the tide has ebbed. Sink holes on the lagoon bed can also be seen. Seepage is most pronounced when the gradient between the levels inside and outside the barrier is steepest,

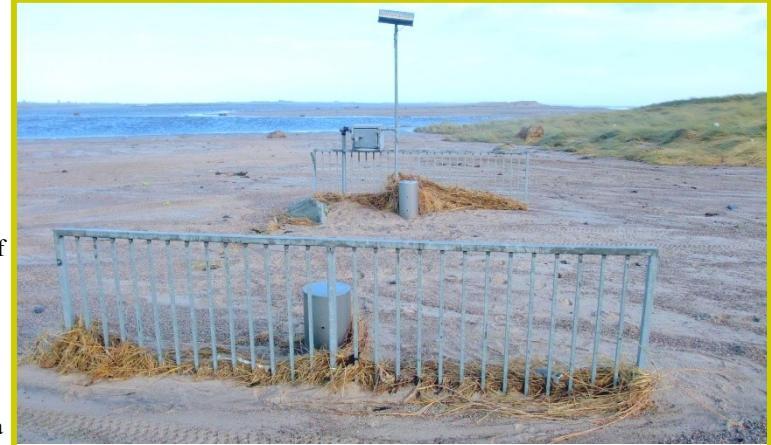
Above: The inlet to the tunnel was buried under tonnes of sediment on 5 February 2014 when the barrier was overwashed at that location. Below: The sediment was removed to relieve flooding and to free the tunnel to continue draining the lagoon.

The barrier was breached by the sea in four places during storms in late January and early February 2014 and the lagoon flooded. Both inlets at the tunnel were overwashed and were buried under sediment during high water of the morning tide on Wednesday 5 February. The Office of

was knocked out of action. Before it failed, the last water level recording transmitted by the logger was 3.61m (= 1.875m ODM) at 9.15am¹³. The lake and surrounding area flooded extensively with hundreds of hectares under water. To protect their lands, local landowners located the buried inlets and freed them to relieve the flooding.

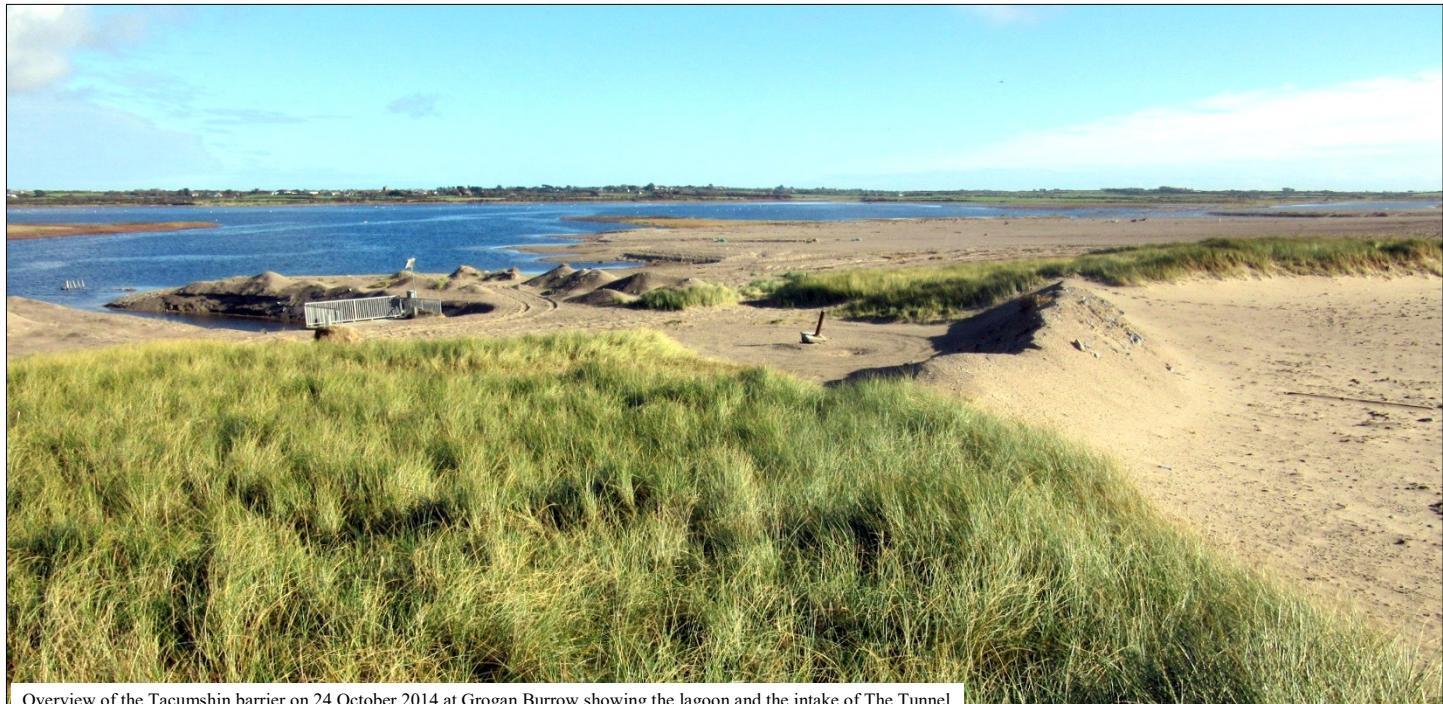
Overview of the Tacumshin barrier on 24 October 2014 at Grogan Burrow showing the lagoon and the intake of The Tunnel.

the OPW and are posted online¹³ Measurements can also be read on a staff gauge erected on the side wall of the eastern intake at the tunnel. Conversion: (staff reading) -1.735m = ODM. Water level in the image above

is 2.1 = 0.365 m ODM, that is, 36.5cm above sea level.

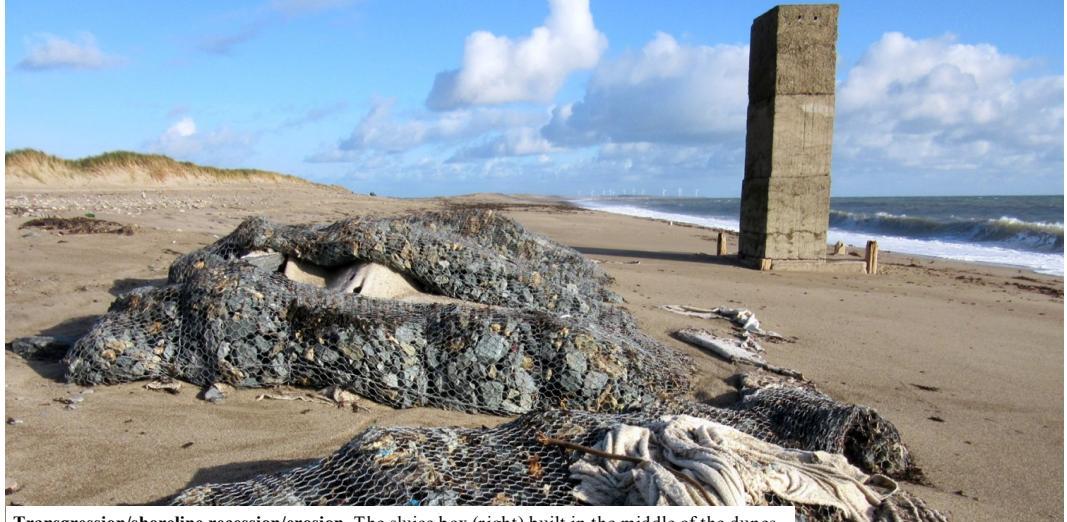
Transgression/shoreline recession/erosion. The sluice box (right) built in the middle of the dunes in 1974 is now located low on the beach face. In the late 1960s the former dunes were almost as tall as the sluice box. The gabion mattresses (foreground) installed by the OPW on the dune crest in 2000 now lie on the foreshore. A rider on horseback on the barrier gallop can be seen on the distant skyline
